LANDSLIP RAPIDLY PROGRESSES TOWARD LIMIT OF DISTURBANCE

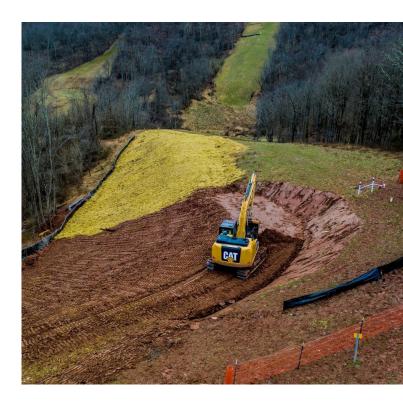
The land was slipping toward a drop that contained a small pond so crews installed a variety of erosion and sediment controls to protect the waterway and control runoff.

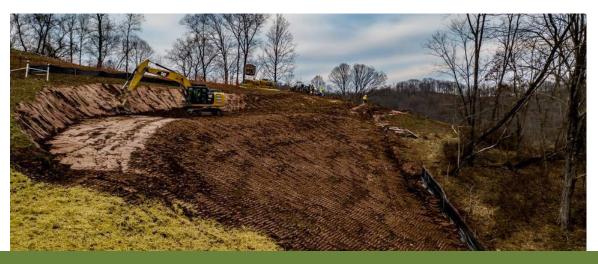
The risk of materials sliding toward the set limit of disturbance was high since they were near a powerline, so crews performed temporary site stabilization by using a benching method to protect employees and materials from slipping.
